The Effect of Reflected Blast Waves in HDPE Mortars

K. L. Kosanke and L. T. Weinman

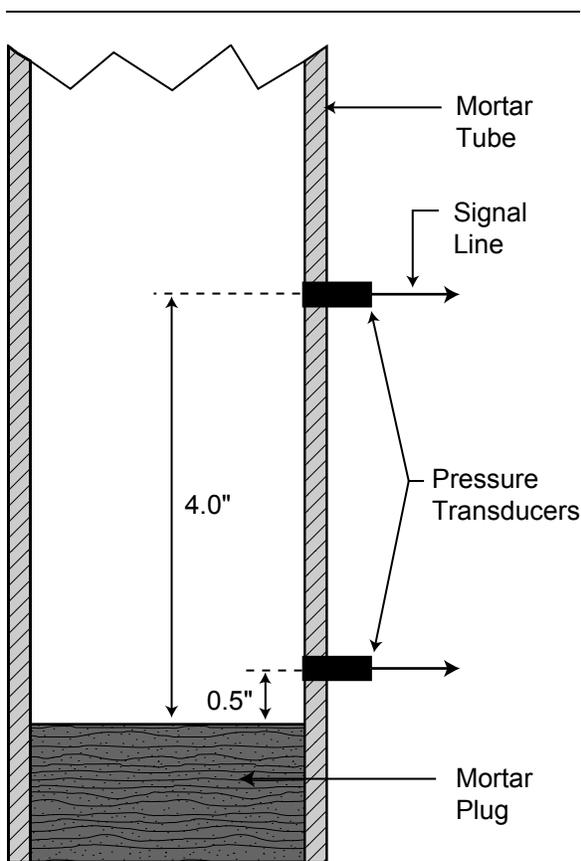
Figure 1. Sketch of the set-up for the first series of mortar tests. (Not to scale.)

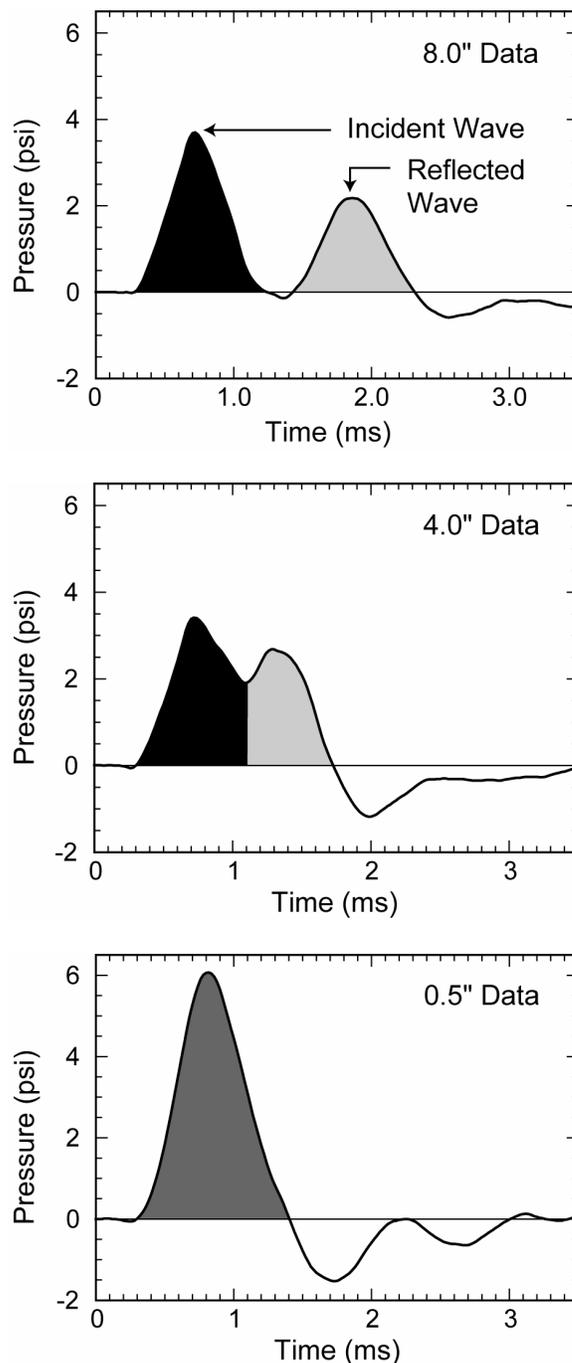
In the data taken at 8.0 inches above the mortar plug, the incident pressure wave is shown as black and the reflected pressure wave, with its somewhat reduced magnitude, is shown as lightly shaded. The incident and reflected waves are clearly resolved and are separated in time by approximately 1.14 ms (milliseconds). The pressure wave needed to travel a total of 16.0 inches (8 inches down to the plug and 8 inches back up to the transducer) or 1.33 feet, during the interval between the arrival times at the transducer. At the temperature in the lab, and the initial temperature of the air in the bore of the mortar, the speed of sound would have been approximately 1130 feet per second. This computes to a time interval between incident and reflected pressure waves of slightly less than 1.18 ms, or about 3 percent longer than was measured. That the pressure wave traveled slightly faster than the speed of sound is consistent with its being a weak blast wave. (This was confirmed by examining details of the shape of the pressure event as seen in the raw, non-smoothed, data.)

In the data taken at 4.0 inches above the mortar plug, the incident and reflected pressure waves are less separated in time, and have started to merge together. In the data taken at 0.5 inch above the mortar plug, the incident and reflected pressure waves are seen to have merged into one. It can be seen that the amplitude of the combined pressure wave is approximately equal to the sum of the incident and reflected waves seen in the data taken higher in the mortar. Thus it seemed clear that the theory was being borne out in practice, but how would an actual mortar react to a pressure pulse sufficiently strong to damage it?

Figure 2. Internal mortar pressure data from the first series of tests.

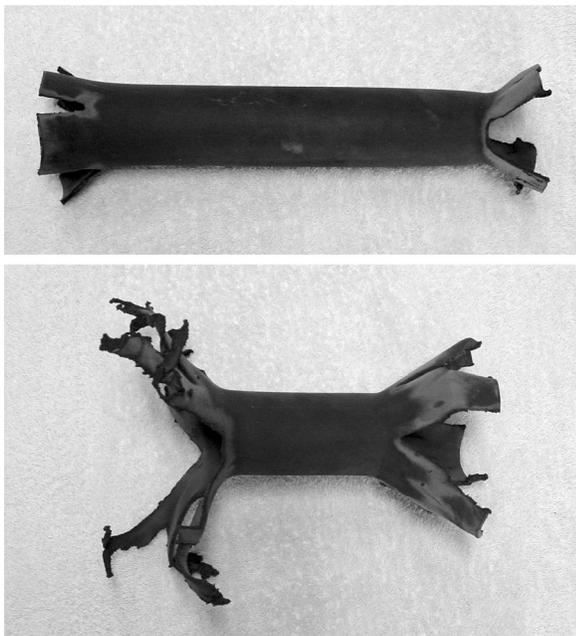
test charge was suspended just inside the mortar near its muzzle. The results of the two tests are shown in Figure 3. In one test a charge mass of only 25 grams of flash powder was used (upper mortar in Figure 3), and in another test a charge of 50 grams was used (lower mortar in Figure 3). With the smaller flash powder charge most of the mortar is undamaged, except for its

two ends, which are damaged almost equally. In the photograph, the left end of the mortar is the muzzle of the mortar (nearest the explosive charge) and the right end is where the plug had been. With the larger explosive charge, the damage is more extreme but is still concentrated at the two ends of the mortar. Thus the reflected blast wave prediction was fully borne out in these tests.

Figure 3. Photographs of the two mortars tested using small explosive charges.
