Further Report on the Testing of Suspect Tiger-Tail Comets

K. L. and B. J. Kosanke

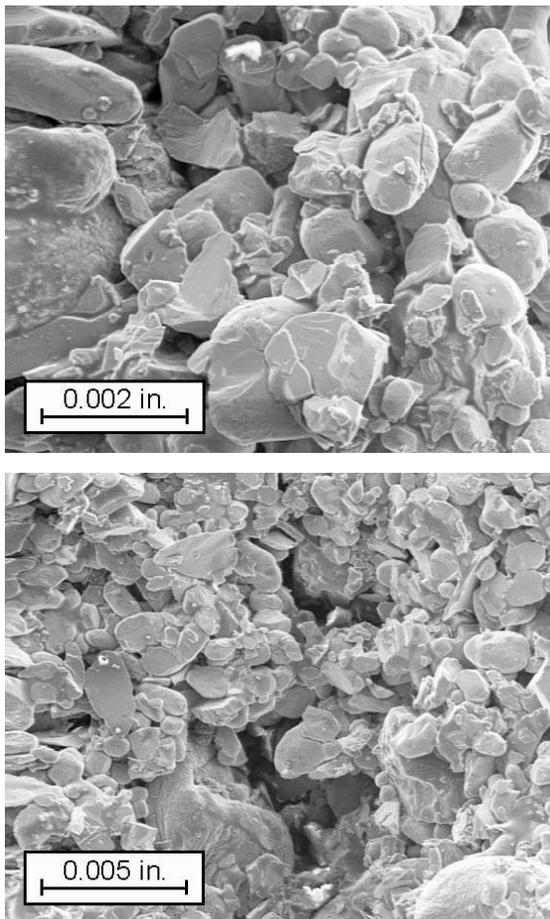
Calculated from the size and mass of the comet, its bulk density was approximately 1.5 g/cm³. Based on its apparent formulation, the maximum theoretical density of the comet composition is approximately 2.5 g/cm³. This difference corresponds to a porosity of approximately 40%, whereas a porosity of roughly 20% is more typical for well-compacted pyrotechnic compositions. The particularly high porosity was confirmed through a microscopic examination, which suggested that gas permeability would also be high. Figure 1 contains two electron micrographs of the comet composition. The upper

micrograph demonstrates the extent to which there tends to be void spaces between individual particles in the comet, which themselves appear somewhat like a collection of boulders in a loose pile. The lower micrograph (taken at lower magnification) is similar in appearance but also documents the occurrence of larger more cavernous voids in the composition.

Figure 1. Electron micrographs of the problematic comets.

those producing the powerful explosions of comet Roman candles occurring previously in Australia,^[3] they share characteristics that are thought to have been the cause of the malfunctions. Both types of comets combine a high energy oxidizer (potassium perchlorate) with small particle size magnalium (in effect constituting somewhat compacted and bound flash powder). Both types of comets have internal structures thought to produce a relatively high degree of gas permeability (fire paths that allow the rapid spread of combustion). The combination of these characteristics is thought to allow the near instantaneous release of large amounts of pyrotechnic energy, occasionally manifesting itself as a powerful explosion. What makes these malfunctions especially problematic is that they are occurring in items generally thought not to be capable of exploding at all.
