## A Report on the Fireworks Accident at Carmel, Western Australia

R. I. Grose<sup>+</sup> and K. L. Kosanke\*

**Keywords :** Carmel explosion, UN hazard classification, safety distance, unlicensed storage

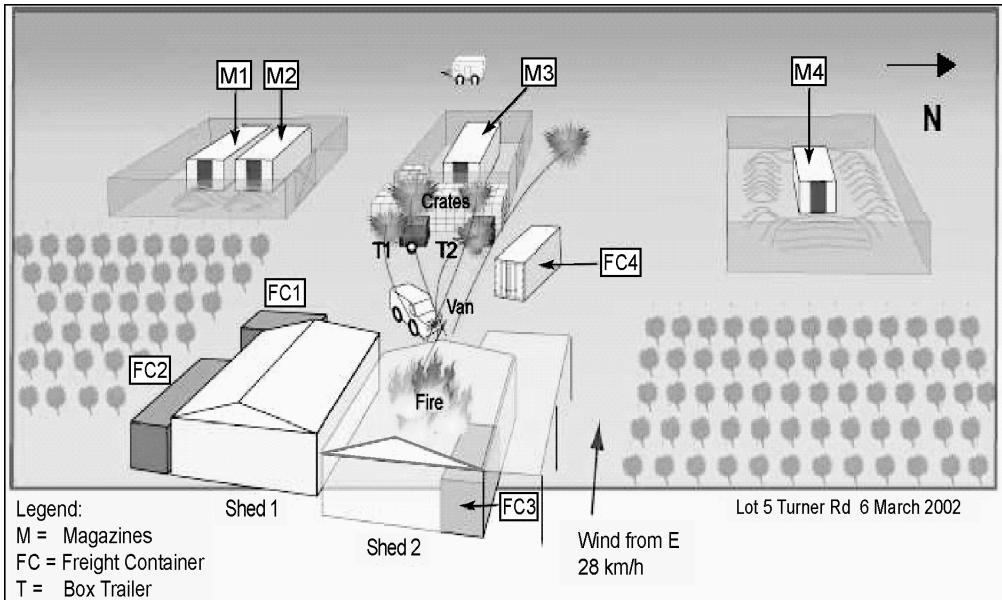
There were four licensed storage magazines (termed M1 to M4) present on the site. The details of these magazines are given in Table 1, and their distribution around the site is presented in Figure 1.

*Figure 1. Outline plan of Carmel site (during initial phase of incident).*

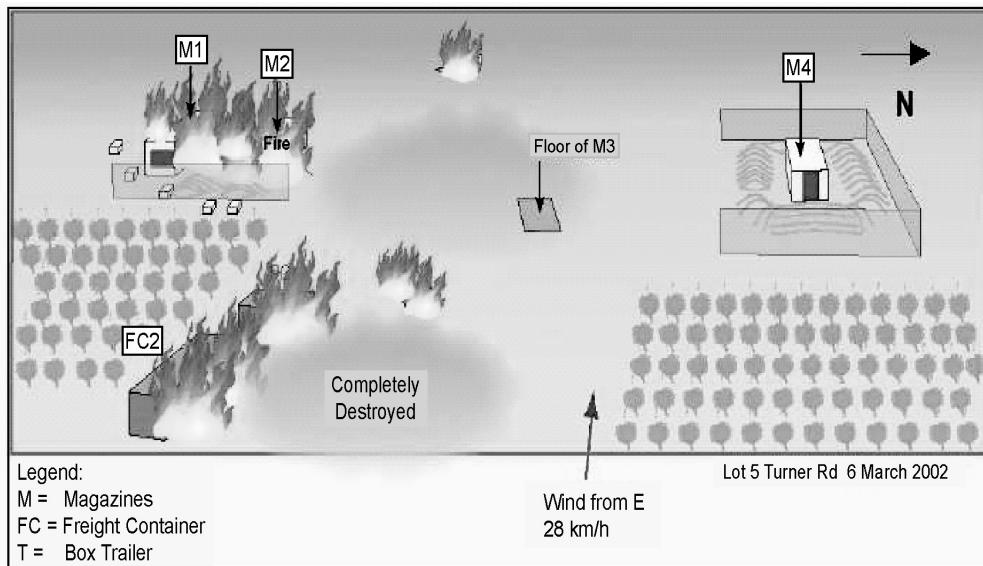
Hot fragments from the explosion of M3 penetrated magazine M1, initiating its contents. No explosion occurred in this magazine, but its contents were consumed by fire. The air blast from the explosion of M3 toppled M1 over by 90 degrees.

Figure 2. Location of structures following explosions.

The remaining structures at the site are shown in Figure 2. A photograph of the damage is shown in Figure 3.

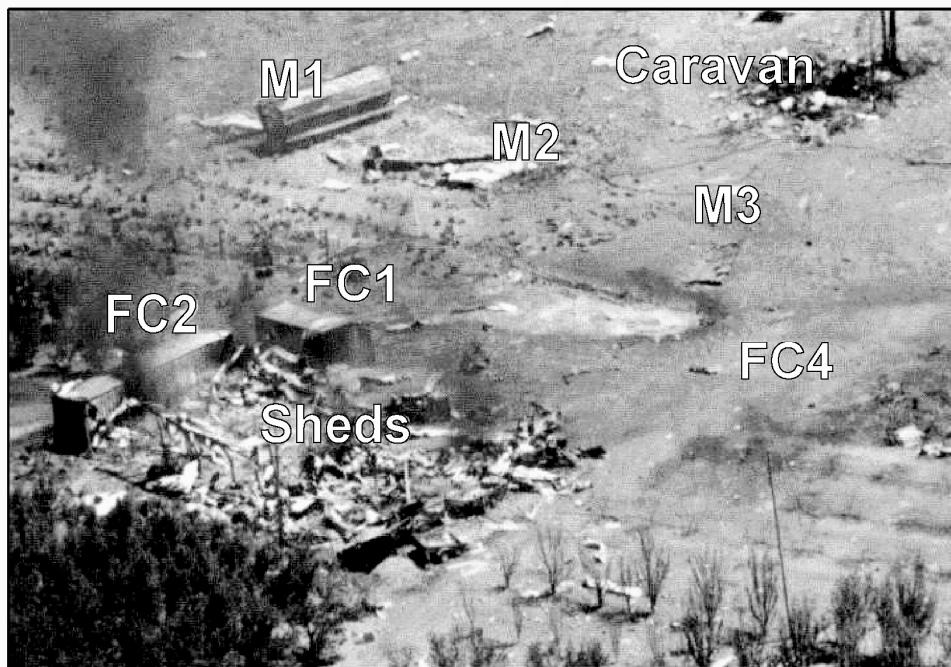
Figure 3. Aerial photograph of site following explosions.

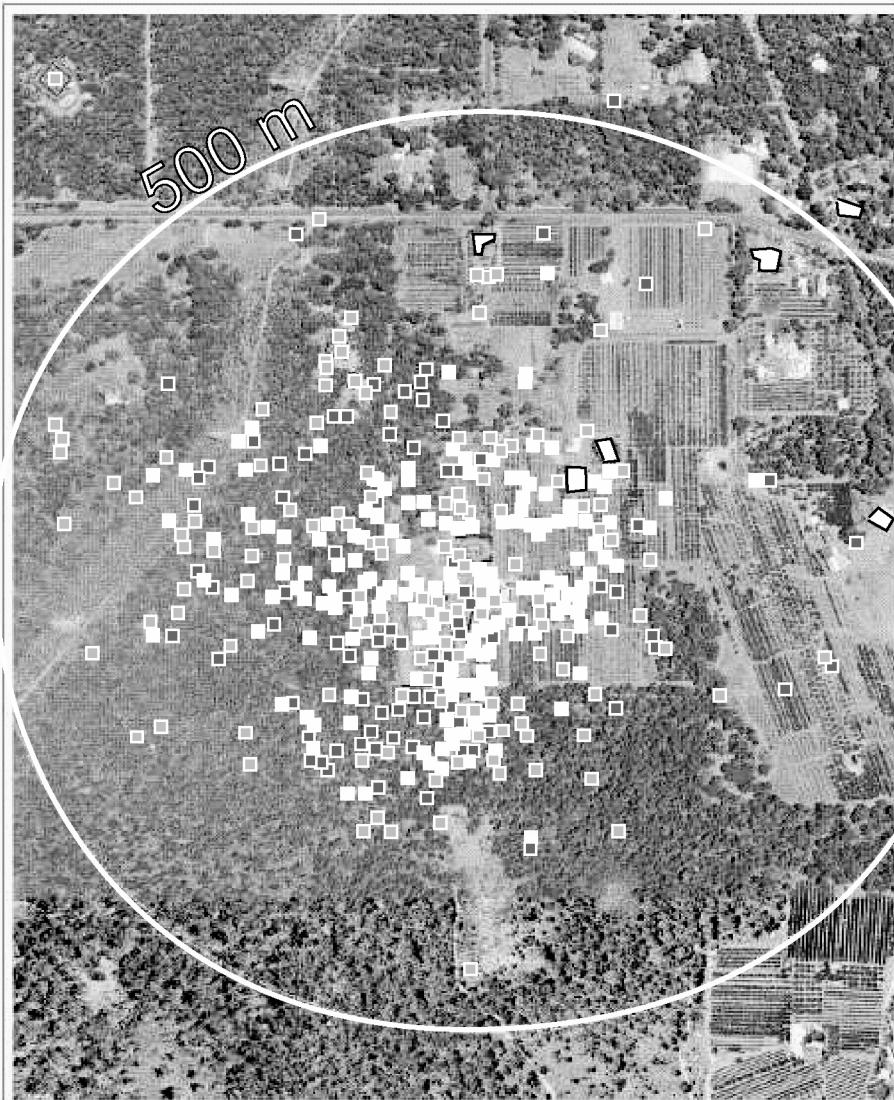
*Figure 4. Combined distribution of shrapnel pieces.*

In addition to the damage at the site of the facility, damage to houses and other structures was reported up to a distance of 4.5 km from the facility. Most of the shrapnel was within 500 m of the

facility. Figure 4 shows the distribution of fragments produced in the course of this incident.
