A Report on the Fireworks Accident at Carmel, Western Australia

R. I. Grose⁺ and K. L. Kosanke^{*}

ABSTRACT

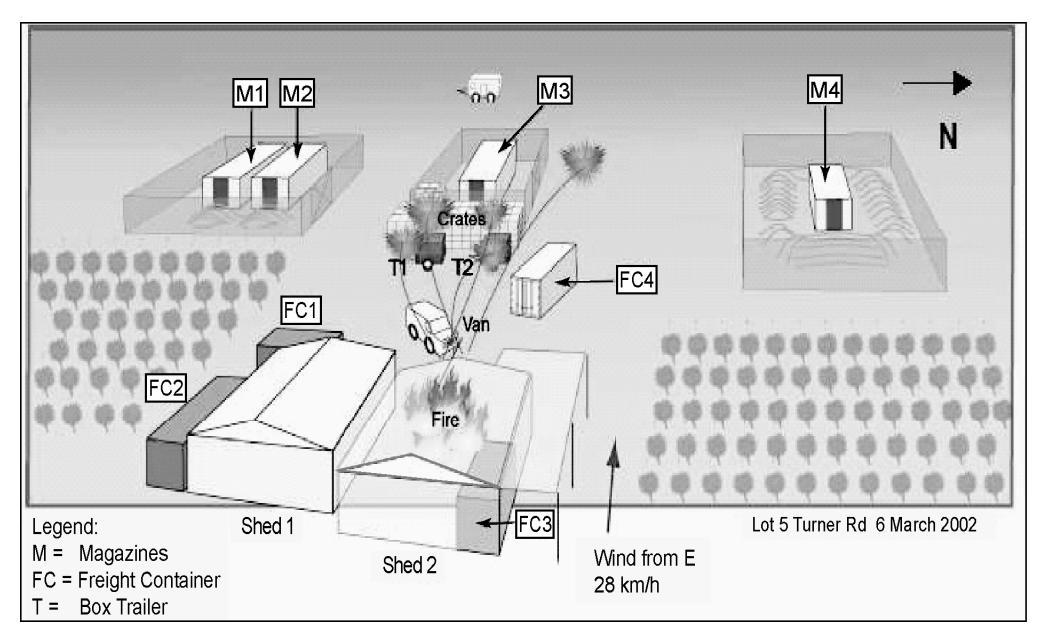
Figure 1. Outline plan of Carmel site (during initial phase of incident).

The facility at Carmel was operated by a fireworks importer and display company. As such, the main business activity of this company was the storage and preparation of fireworks intended for public displays. Pyrotechnic items for those displays were imported into Australia for storage at Carmel; from there, they would be taken to display sites throughout the country. The first firework storage license for the Carmel site was issued in 1985, and this was subsequently altered and added to several times prior to the incident. There were four licensed storage magazines (termed M1 to M4) present on the site. The details of these magazines are given in Table 1, and their distribution around the site is presented in Figure 1.

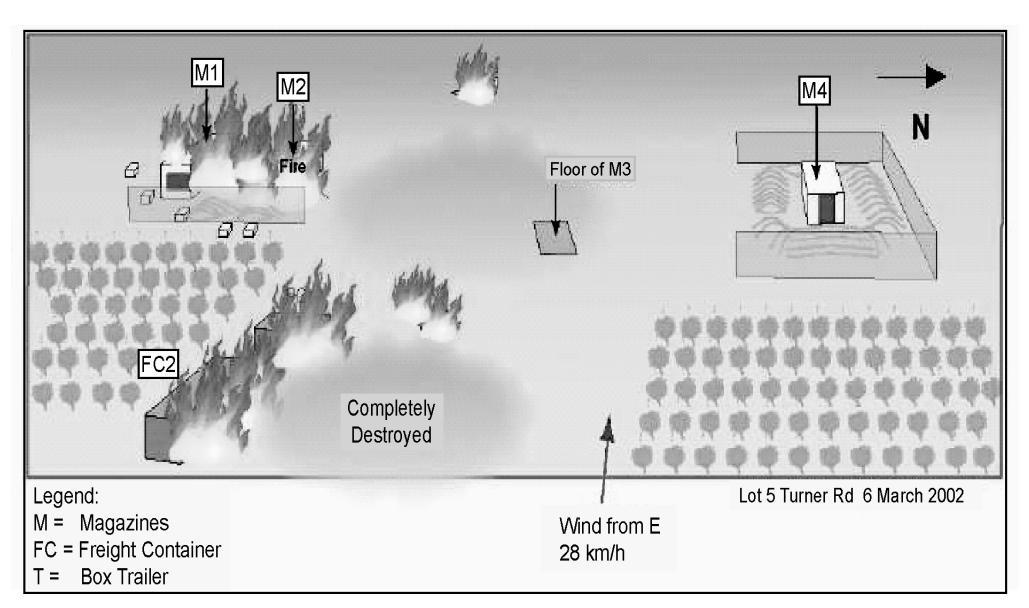
Figure 2. Location of structures following explosions.

Shortly after the ignition of materials inside FC4, it exploded violently, sending a large quantity of steel shrapnel pieces toward magazines M2 and M3. These magazines were penetrated by the shrapnel pieces, and their contents were initiated by impact, friction or heat from the impacting fragments or, more likely, from a combination of these mechanisms. Around 5 minutes after the explosion in FC4, the contents of M2 underwent a partial detonation or a rapid deflagration. There was insufficient evidence to determine which of these explosion mechanisms was responsible for the resultant pressurization of the steel container, which failed at its welded seams. Some parts of the structure, such as roof panels and doors, were projected a short distance, and the remaining burning contents were ejected from the container.

Eleven minutes after the partial destruction of M2, magazine M3 was completely destroyed by a large explosion of unexpected violence. The investigation attributed this explosion to the partial detonation or rapid deflagration of the contents. Witnesses reported a large fireball (approximately 100 m in diameter), and a large

cloud of smoke following this explosion. Small pieces of hot shrapnel were projected several hundred meters from the magazine site by the explosion in M3. Only the floor of M3 remained – the door (weighing 170 kg) was projected 370 m and the roof (380 kg) was found 295 m away. The rest of the magazine had fragmented.

Hot fragments from the explosion of M3 penetrated magazine M1, initiating its contents. No explosion occurred in this magazine, but its contents were consumed by fire. The air blast from the explosion of M3 toppled M1 over by 90 degrees.

The remaining structures at the site are shown in Figure 2. A photograph of the damage is shown in Figure 3.

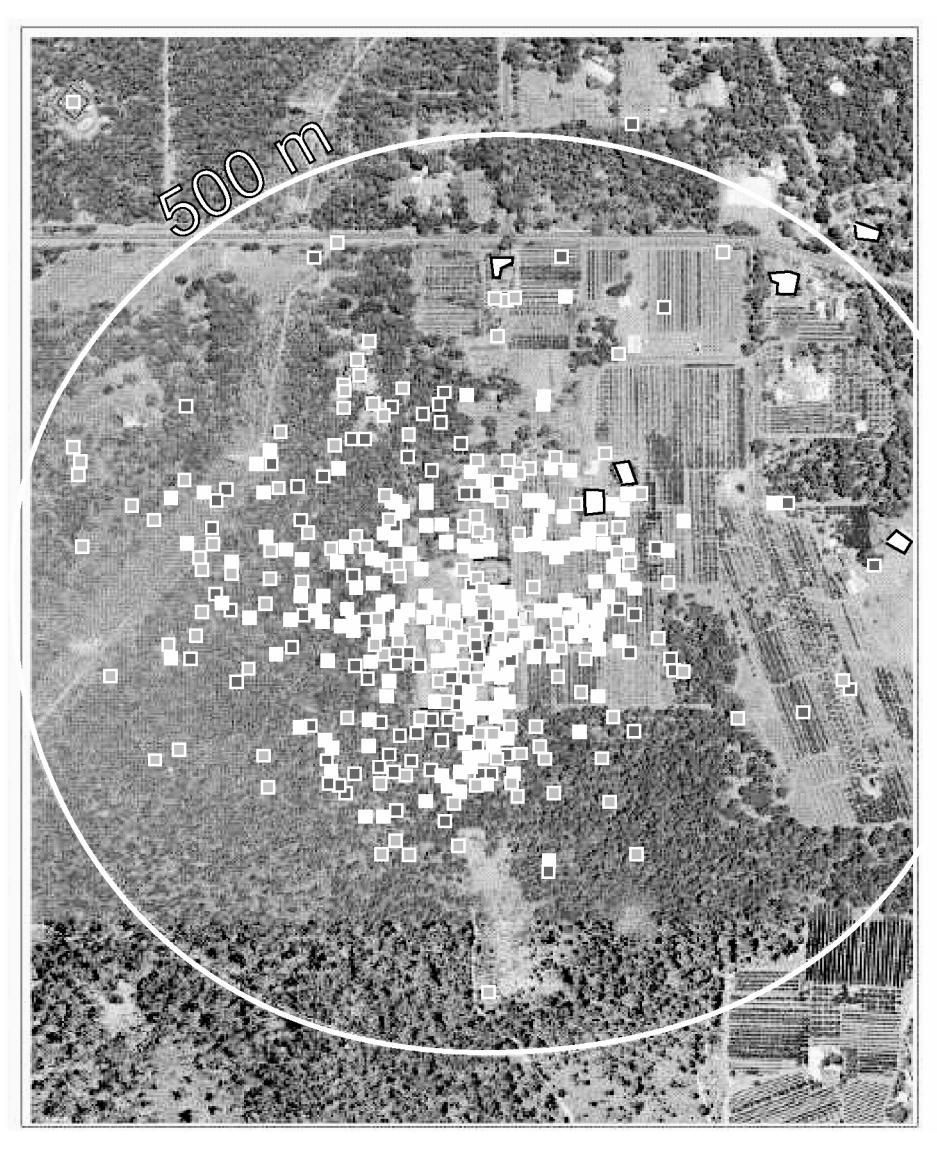
Figure 4. Combined distribution of shrapnel pieces.

In addition to the damage at the site of the facility, damage to houses and other structures was reported up to a distance of 4.5 km from the facility. Most of the shrapnel was within 500 m of the facility. Figure 4 shows the distribution of fragments produced in the course of this incident.
